APPENDIX A

A-2 RIPARIAN MONITORING ANALYSIS SOAP MITIGATION PLAN MAGGIE CREEK WATERSHED RESTORATION PROJECT 1997 AND 1999

APPENDIX A-1
1999 PROGRESS REPORT FOR THE SOAP MITIGATION
PLAN IMPLEMENTATION AND
MITIGATION OF POTENTIALLY IMPACTED
SPRINGS AND SEEPS

SUBJECT: 1999 Progress Report for the SOAP Mitigation Plan Implementation

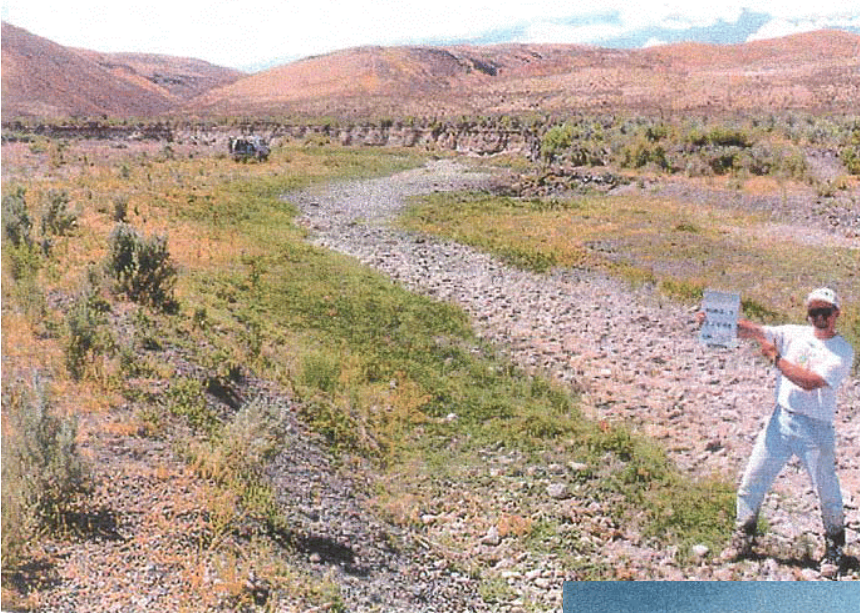
Figure 2. Maggie Creek MAG-3, T-1, Up, 7/27/94. H-7 Pasture. Habitat conditions are extremely poor. Although portions of the stream became dry in 1994, grazing practices in prior years have prevented establishment of willows and other riparian plant species.

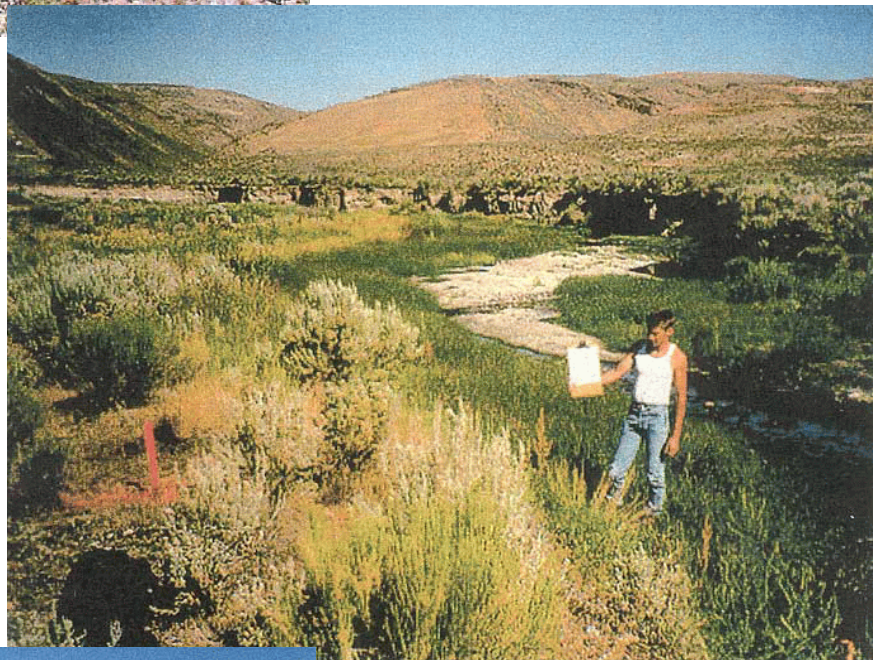
Figure 3. Maggie Creek, MAG-3, T-1, Up, 7/19/96. H-7 Pasture. Early stages of floodplain recovery are evident. Increased growth or riparian vegetation has allowed for the trapping of sediment and formation of point bars which eventually become part of a new floodplain.

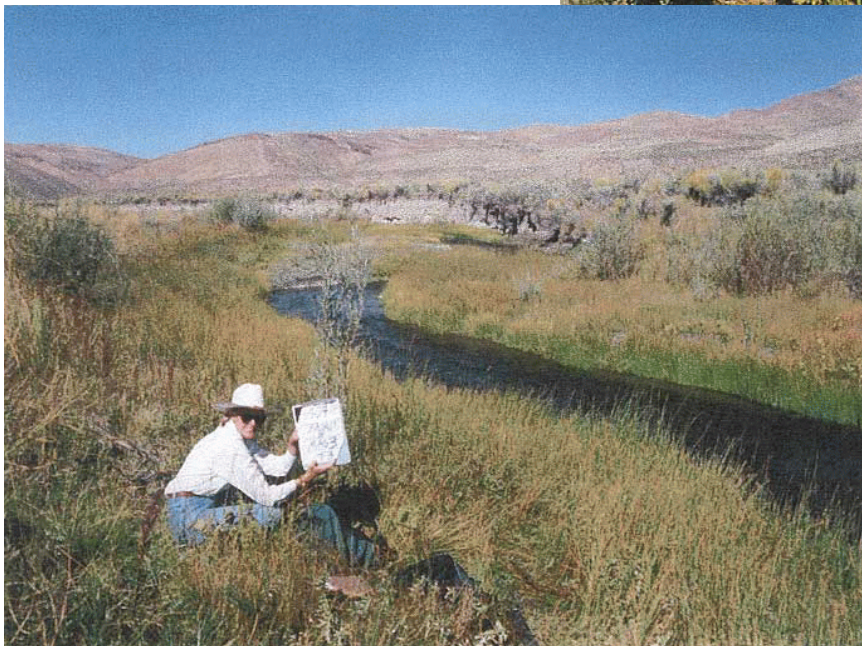
Figure4. Maggie Creek, MAG-3, T-1, Up 9/24/98. H-7 Pasture. Point bars have become completely colonized with vegetation and are now stable. The channel has become narrow and deep allowing for the formation of pools and undercut banks. Note growth of new willows on previously dry floodplains.

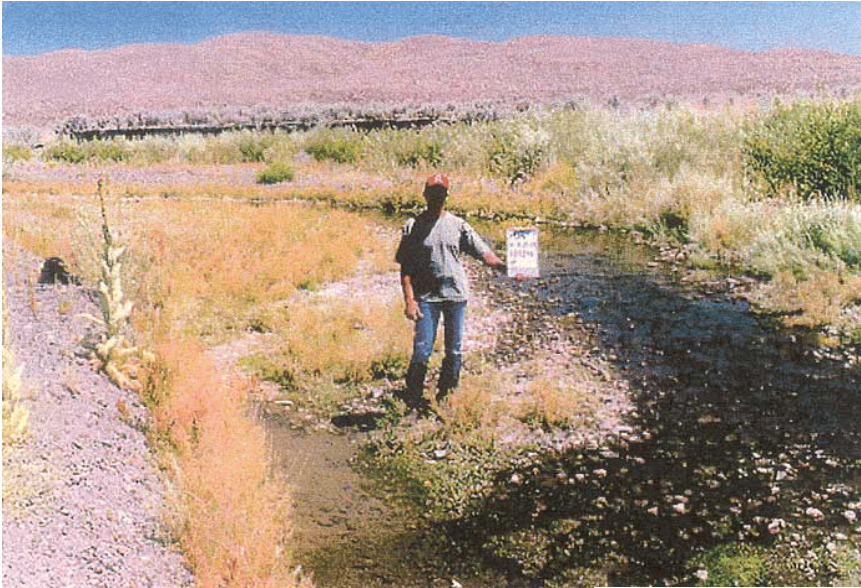
Figure 5. Maggie Creek MAG-20, T-1, Up, 7/19/94. Coyote Pasture. Although excellent growth of willows has occurred since this area was first rested in 1992, the channel remains wide and shallow. Even during bankful conditions, the stream cannot access the floodplain forming the left bank.

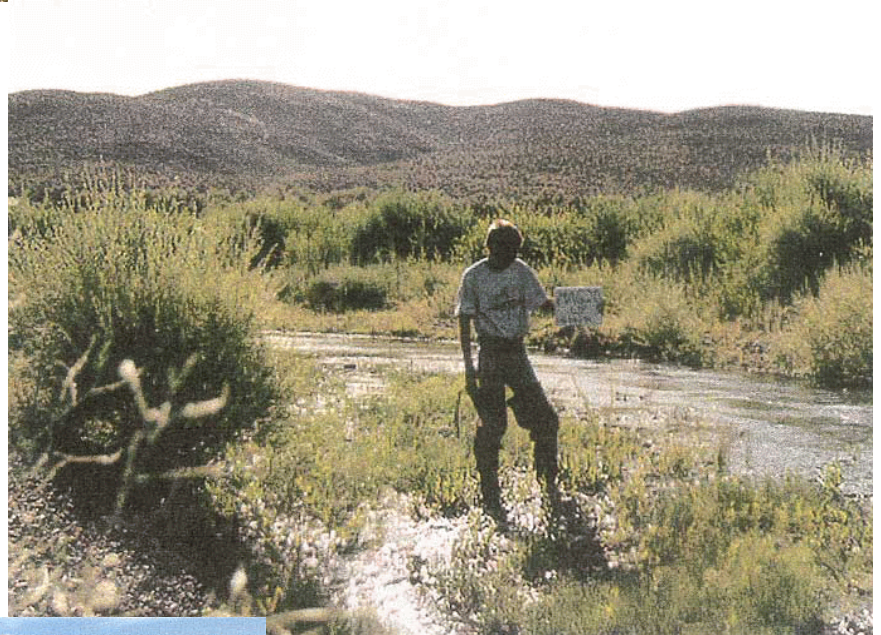
Figure 6. Maggie Creek, MAG-20, T-1, Up 8/1/96. Coyote Pasture. Growth of riparian vegetation is increasing. Although the bankful stream channel remains wide and shallow, vegetation colonizing lower velocity areas is beginning to trap sediments. This is the process by which a new, more accessible floodplain forms.

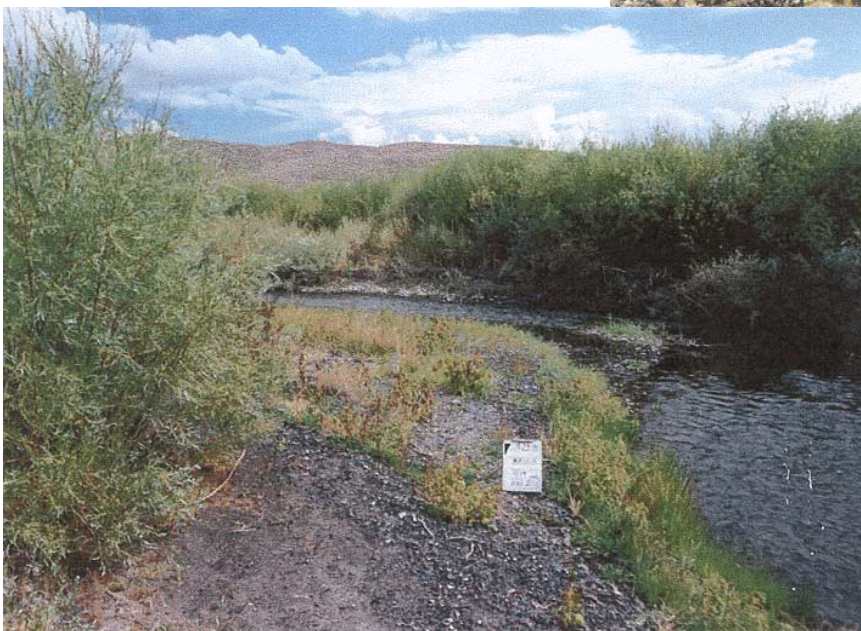
Figure 7. Maggie Creek, MAG-20, T-1, Up, 9/23/98. Coyote Pasture. A new floodplain accessible to the stream is beginning to form on the left. The result is a place for vegetation to become established which in turn will lead to formation of a narrower, deeper stream channel.

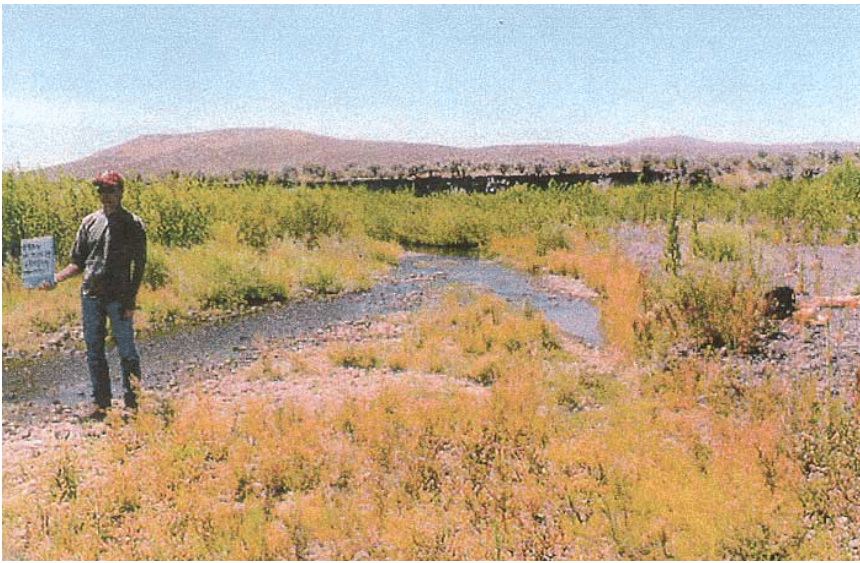
Figure 8. Maggie Creek, MAG-20, T-1, Down, 7/19/94. Coyote Pasture. Early Signs of recovery in the form of vigorous willow growth are evident after two years of rest.

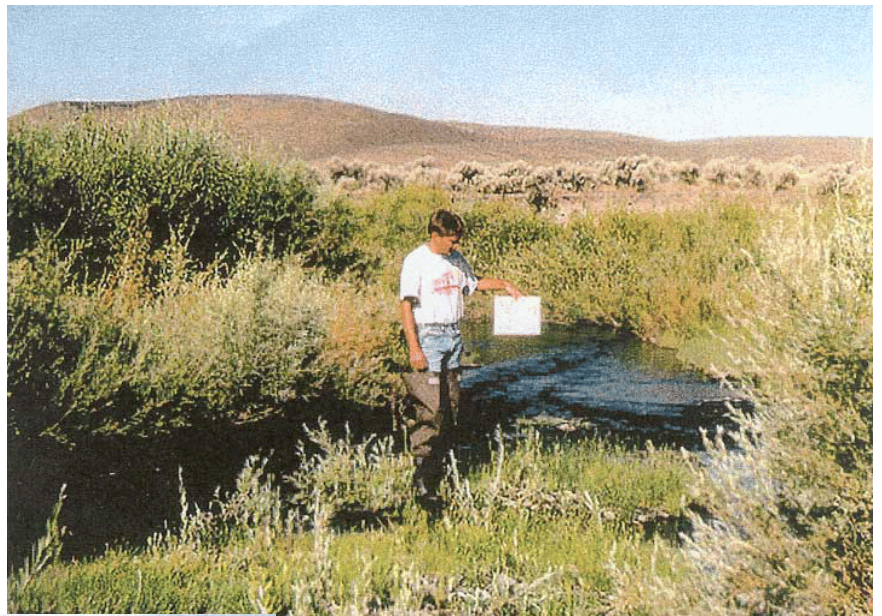
Figure 9. Maggie Creek, MAG-20, T-1, Down, 8/1/96. Coyote Pasture. Continued recovery is resulting in stable, well vegetated streambanks and an increasingly deep, narrow stream channel.

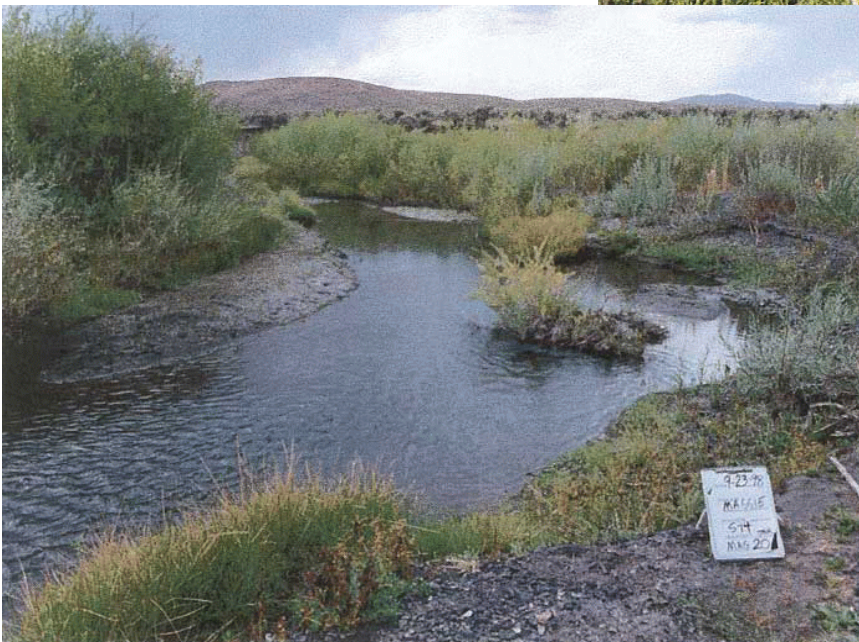
Figure 10. Maggie Creek, MAG-20, T-1, Down, 9/23/98. Coyote Pasture. The recovery process is being influenced by excessive sediment deposition. The expanding riparian zone in the Coyote Pasture is becoming increasingly effective at trapping sediment generated from private lands upstream. In 1998, numerous point bars (shown to the left of the watered channel) as well as mid channel bars were observed within the Coyote Pasture. Although sediment deposition is a necessary component of floodplain building, the result here is a decrease in the width of the measured riparian zone and in factors associated with bank development such as shorewater depth and woody vegetation overhang.

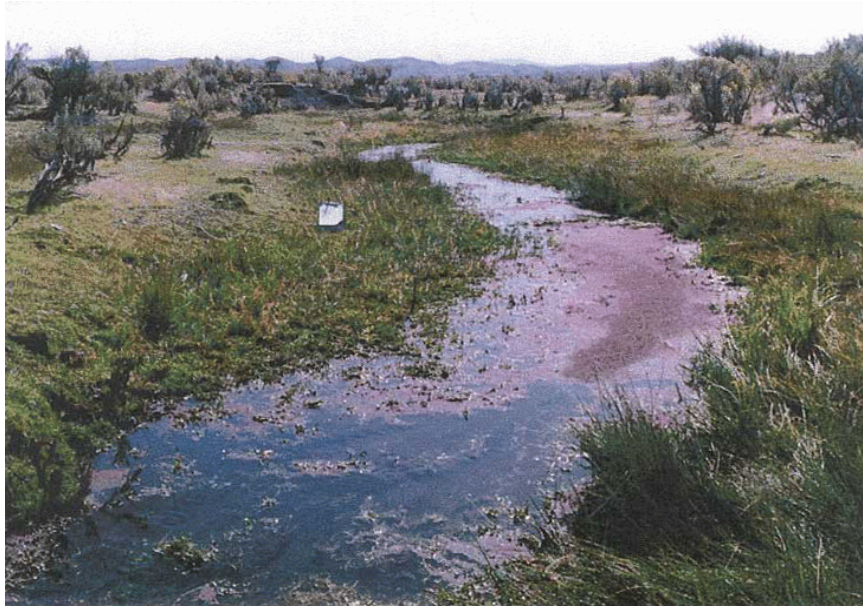
Figure 11. Indian Jack Creek, Jack 1 Pasture, S-1, T-1, Down 9/15/92. *Habitat conditions are poor. An exposed, shallow channel has allowed for extensive growth of algae. The streambottom is comprised almost exclusively of fine sediments. Riffles and quality pools are virtually nonexistent, while there is essentially no depth at the shorewater interface.*

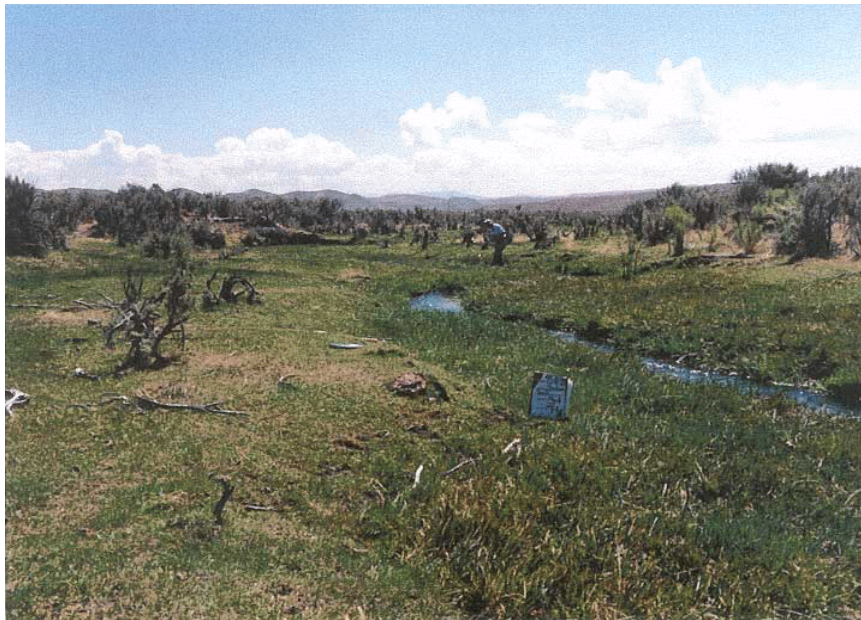
Figure 12. Indian Jack Creek, Jack Pasture 1, S-1, T-1, Down 8/11/98. *Habitat conditions have shown excellent improvement since 1992. The stream is much narrower and deeper resulting in increased bank storage, cooler summer stream temperatures, and formation of undercut banks and quality pools. Both substrate composition and embeddedness of substrates have also improved. Note sagebrush on the left bank which was alive in 1992 has died in response to an elevated water table. Lahontan cutthroat trout were documented for the first time at this location in 1998.*

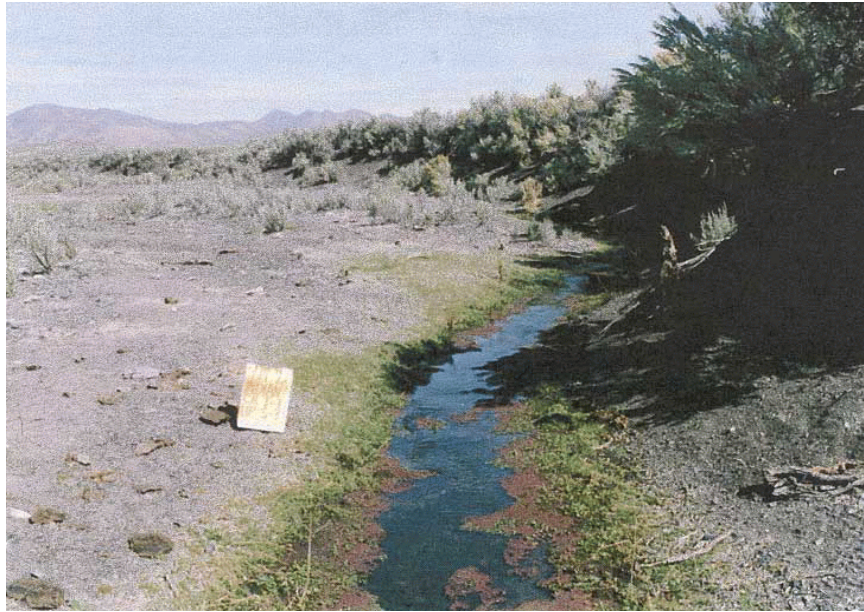
Figure 13. *Indian Jack Creek, Lower North Native, S-3, T-1, Up, 9/14/92. Habitat conditions are extremely poor. There is virtually no riparian zone development, while the stream channel is completely exposed. Substrates are covered with algae and fine sediments. The floodplain is becoming increasingly dry as evidenced by the invasion of young sagebrush.*

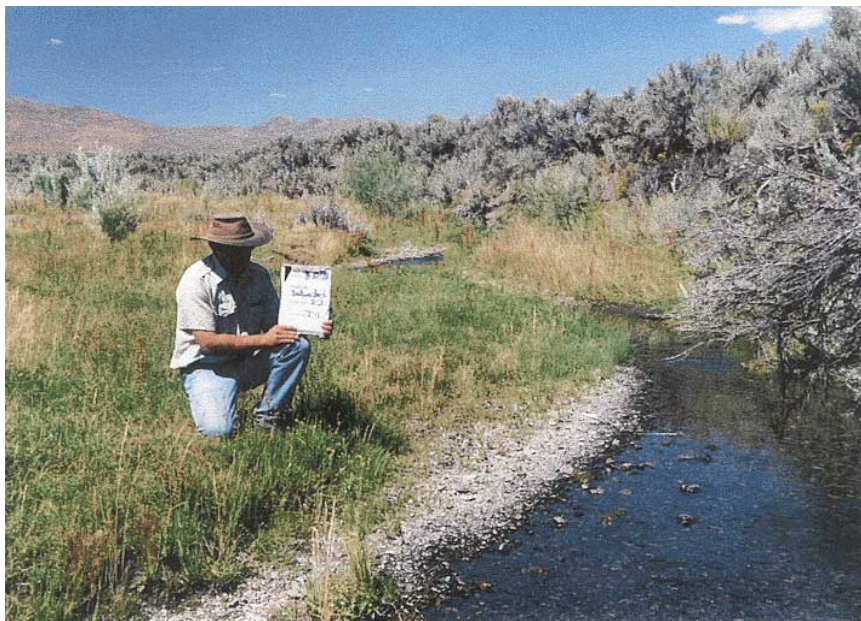
Figure 14. *Indian Jack Creek, Lower North Native, S-3, T-1, Up, 8/17/98. Improvement has been dramatic since 1992. The floodplain has become much more hydrated (note the replacement of sagebrush with willow), while substrates are becoming cleaner and less embedded. Note the increase in sinuosity and the development of a “buffer zone” between the stream channel and the old cut banks.*

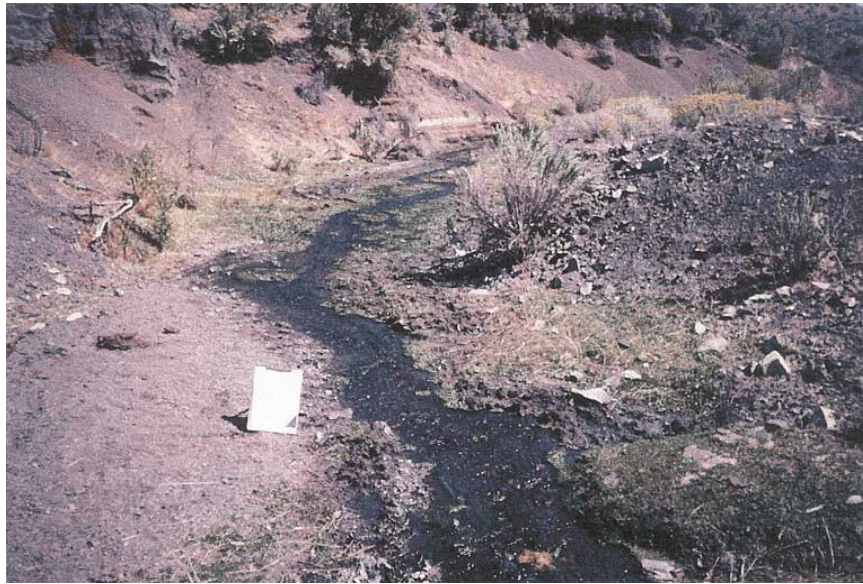
Figure 15. Indian Jack Creek, Lower North Native, S-6, T-1, Down, 9/16/92. As with downstream areas, habitat conditions were extremely poor in 1992. The channel is completely exposed, while there is almost no riparian zone.

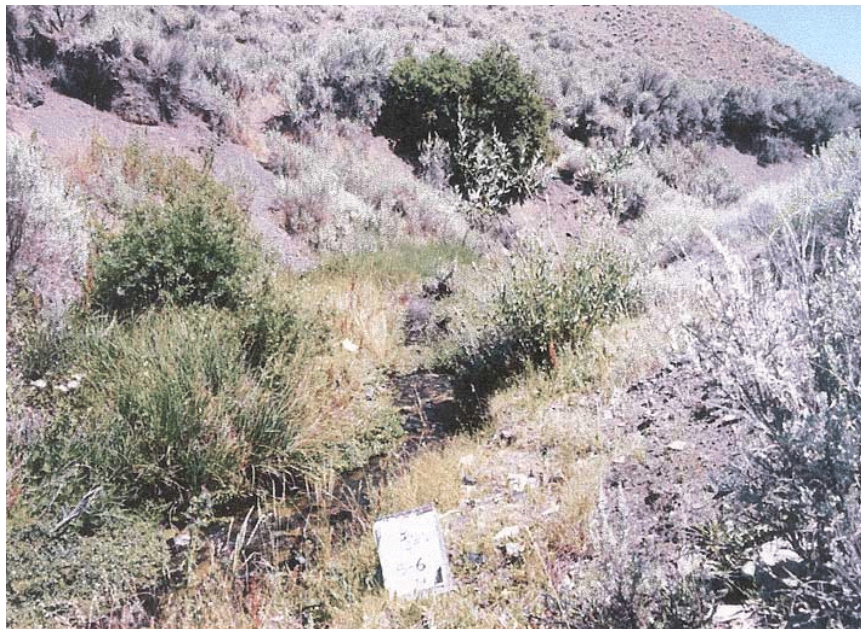
Figure 16. Indian Jack Creek. Lower North Native, S-6, T-1, Down, 8/17/98. Improvement in the riparian zone has led to significant improvement of instream fisheries habitat. Vegetation is beginning to overhang the water column providing for shading and an increase in the shorwater depth. The channel is narrower and deeper, while streambottom substrates are much cleaner and are less embedded by fine sediments. Note the establishment of willow on a site previously occupied by sagebrush.

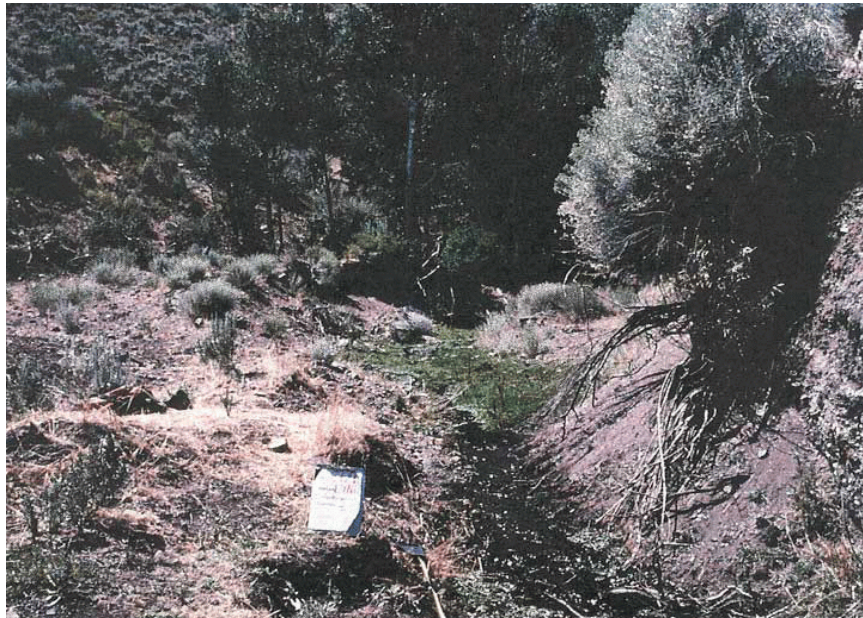
Figure 17. *Lynn Creek, Lower North Native, S-2, T-1, Up, 8/12/91. Habitat conditions are very poor as shown by almost complete absence of riparian zone. The stream channel is shallow and exposed, while there is no recent evidence of regeneration by willow or aspen. In addition, significant portions the Lynn Creek drainage are entrenched as a result of past mining and road building activities including poor placement of culverts.*

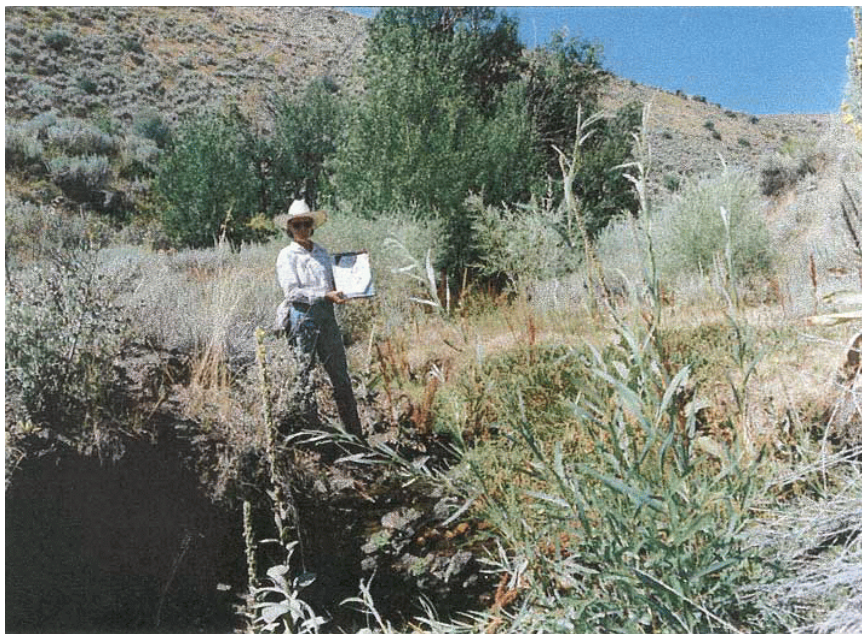
Figure 18. *Lynn Creek, Lower North Native, S-2, T-1, Up, 8/17/98. Excellent growth and establishment of willow and aspen have occurred since 1991. Although the stream channel remains entrenched, improvement in the riparian zone is allowing for a reduction in bank erosion rates and improved composition of streambottom substrates.*

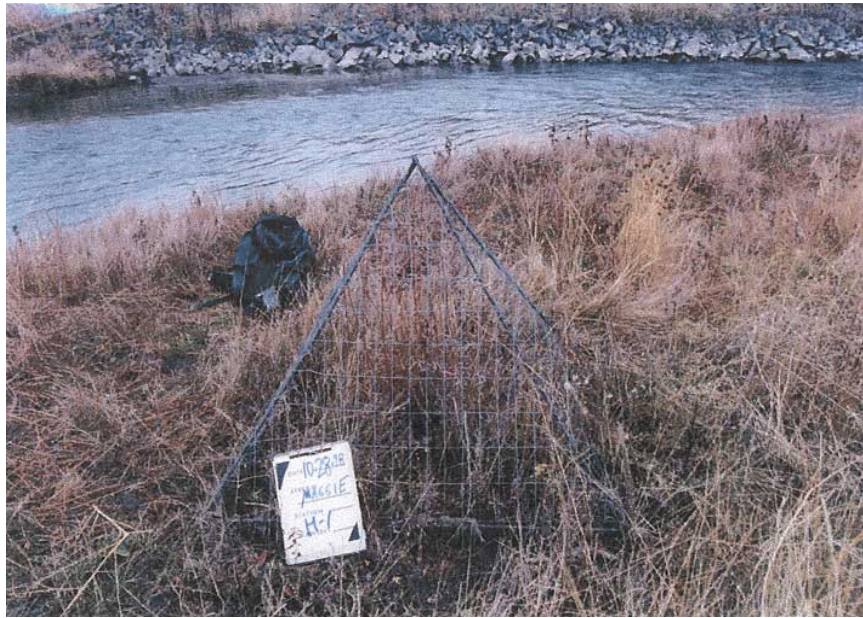
Figure 19. Maggie Creek, H-1. Utilization Cage. 10/28/98. *This pasture was grazed for about two weeks in late October in 1998. Use of herbaceous riparian vegetation was estimated as slight, while use on willows was estimated as moderate. Increased establishment of riparian vegetation within this field plays an important role in reducing any erosion potential associated with discharge flows.*

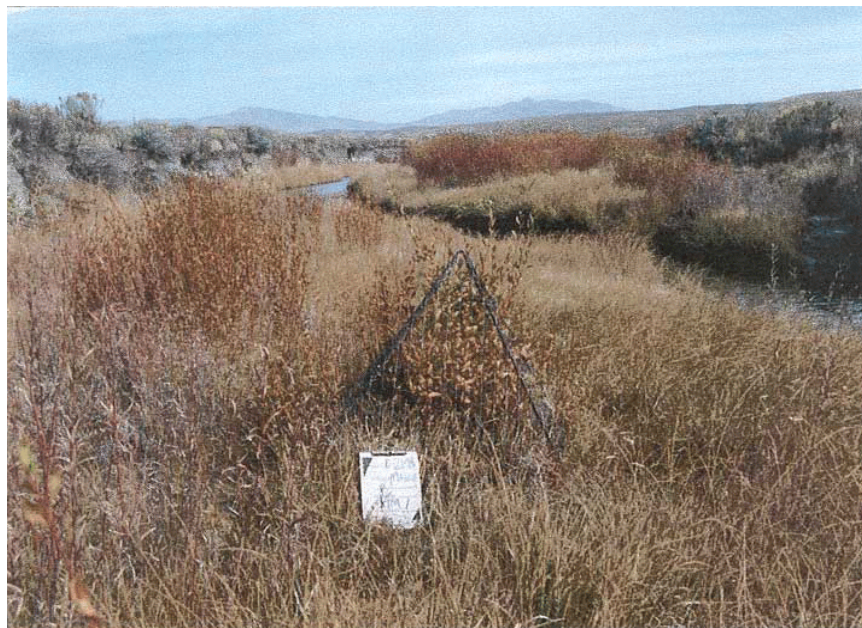
Figure 20. Maggie Creek, SIM1. Streamside Utilization Cage. 10/21/98. *Although this field was grazed for about one month in March of 1998, there was no detectable difference in use of grazed and ungrazed (caged) plants by October. Recovery of both the stream channel and associated riparian zone along this section of Maggie Creek is excellent as shown by stable, well vegetated streambanks and a deep narrow stream channel.*

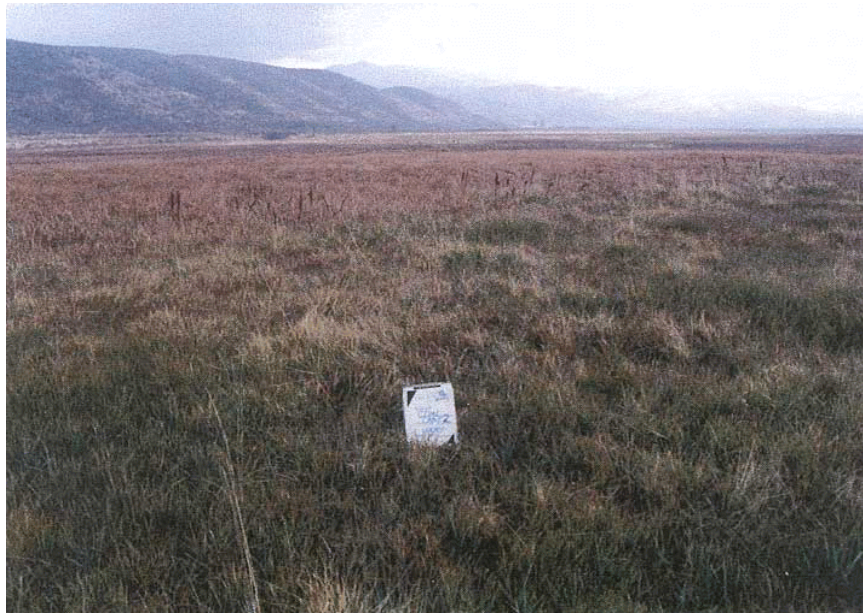
Figure 21. Cow Camp 2 (upper field). 10/28/98. *This field was grazed for a limited time in April and for about one month in July. In 1998. Use was estimated as slight on herbaceous vegetation and moderate on willows by the end of October. This semi-wet sedge/rush community is naturally resilient to grazing and responds well to short duration use in July.*

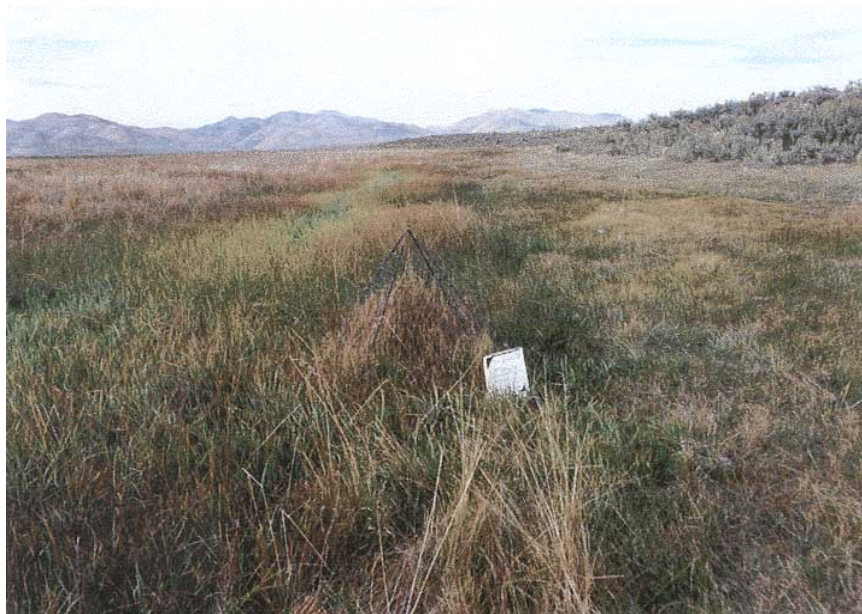
Figure 22. Jack Pasture 1 (upper field). Utilization Cage. 10/28/98. *Grazing occurred mostly in July in 1998. Utilization of both herbaceous vegetation and willows was estimated as light. As with other large, naturally irrigated meadow communities within the MCWRP area, this field showed very little impact to short duration summer grazing.*

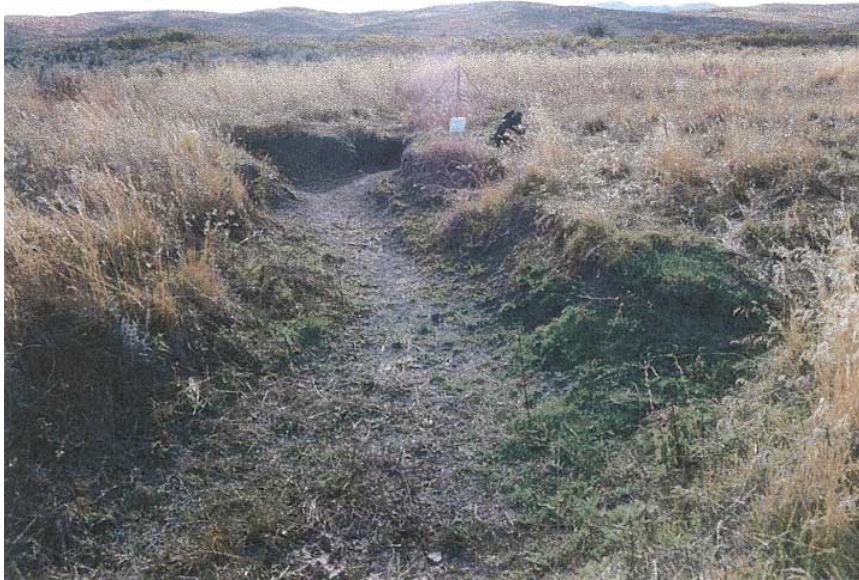
Figure 23. Jack Pasture 2. Utilization Cage. 10-14-98. *Grazing occurred for about three weeks in August of 1998. Utilization was estimated as slight to light on both woody and herbaceous vegetation. Although the headcut shown in the photograph has advanced upstream about one foot over the past two years, areas of bare soil are becoming increasingly colonized and stabilized with vegetation.*

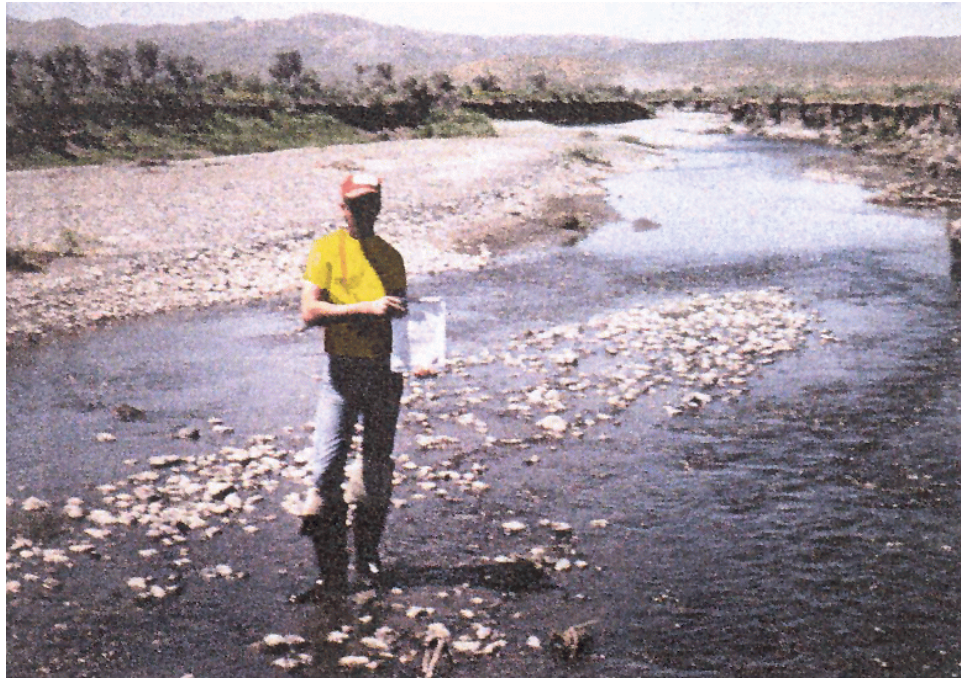
Maggie Creek. Station 4, Transect 1. 7/5/86. Degraded habitat conditions including a wide, shallow channel; excessive deposition of gravels and fine sediments; lack of riparian vegetation; and, absence of a functional floodplain characterized much of Maggie prior to implementation of the South Operation Area Project (SOAP) plan.

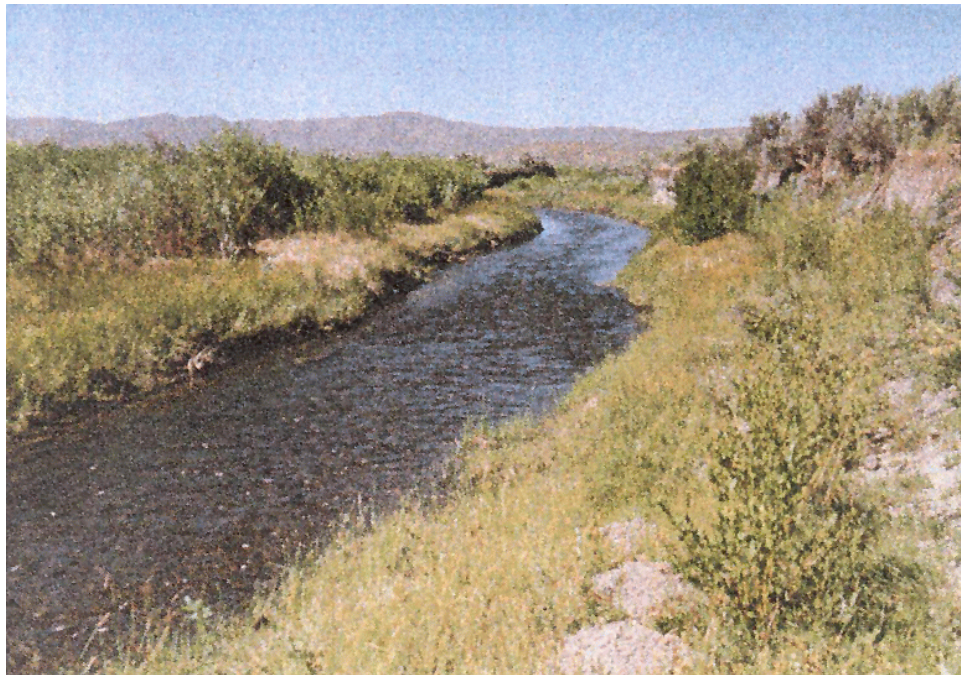
Maggie Creek. Station 4, Transect 1. 7/1/99. Stream and riparian habitat conditions have improved dramatically since the SOAP Mitigation Plan was implemented in 1993. Although this area is still grazed by livestock, changes in the timing and duration of grazing have resulted in development of a much narrower, deeper stream channel as well as stable, vegetated streambanks. Most importantly, Maggie Creek now has a functional, hydrated floodplain and a healthy riparian zone.

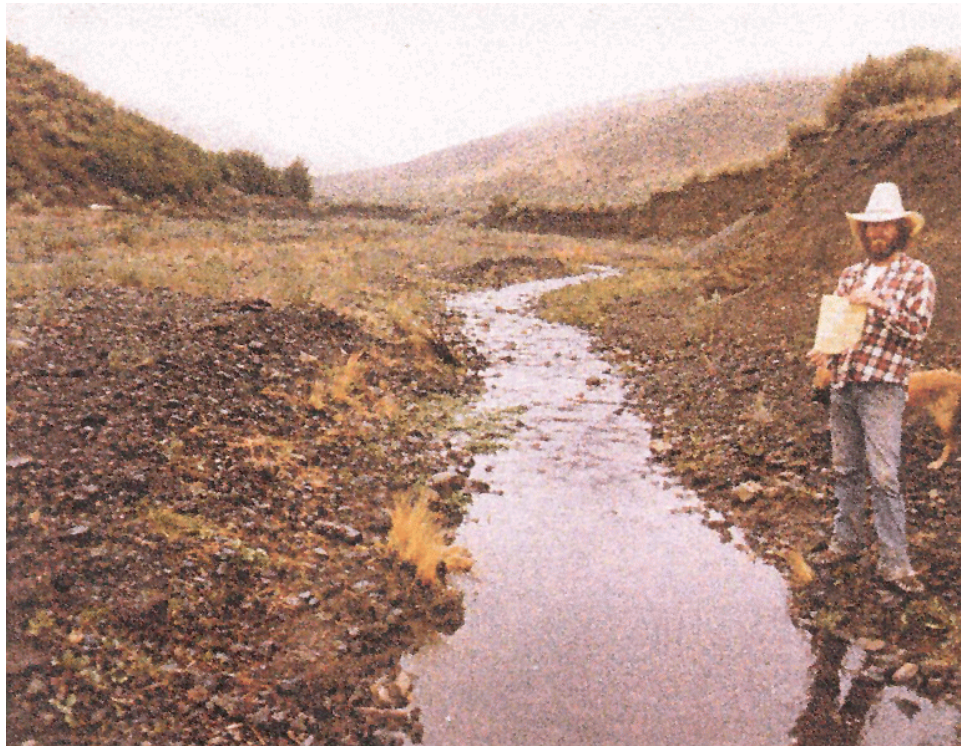
Coyote Creek. Station 2, Transect 2. 8/18/77. Prior to the implementation of the South Operations Area project (SOAP) Mitigation Plan, habitat conditions along Coyote Creek were extremely poor as shown by a shallow, exposed channel and nearly complete absence of streambank vegetation. Under these conditions trout are susceptible to excessive summer water temperatures as well as lethal icing conditions in winter.

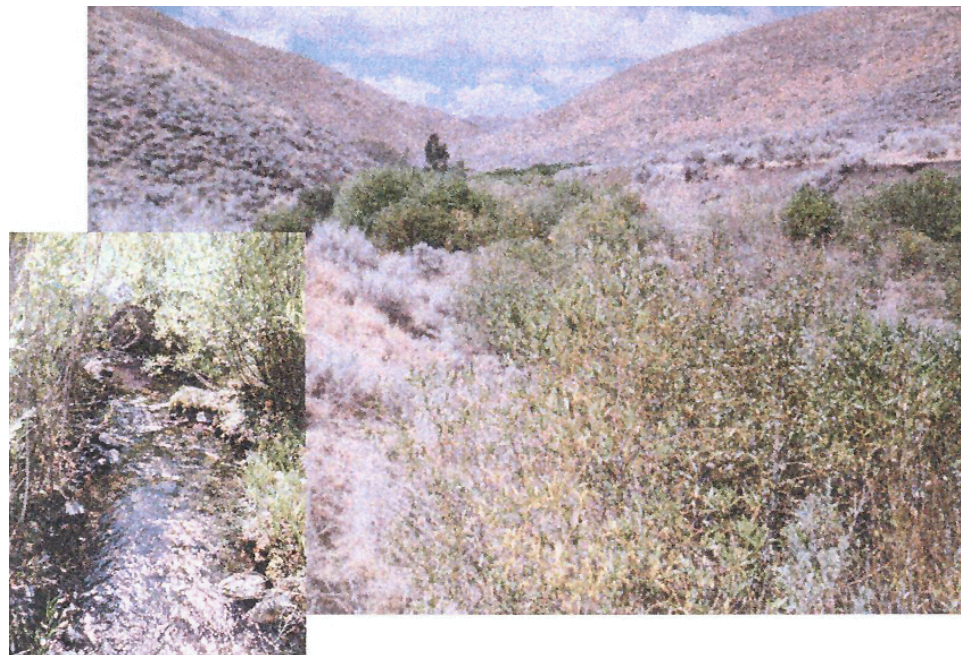
Coyote Creek. Station 2, Transect 2. 9/20/99. Changes in grazing management initiated through the SOAP mitigation Plan have allowed for the vigorous growth and establishment of a healthy willow riparian zone. As shown in the insert, Coyote Creek is not characterized by stable, well vegetated streambanks and a much narrower and deeper stream channel. The result is greatly improved habitat conditions for the threatened Lahontan cutthroat trout.
